AusNOG 2024

Behind the curtain of building Australia's most secure subsea systems

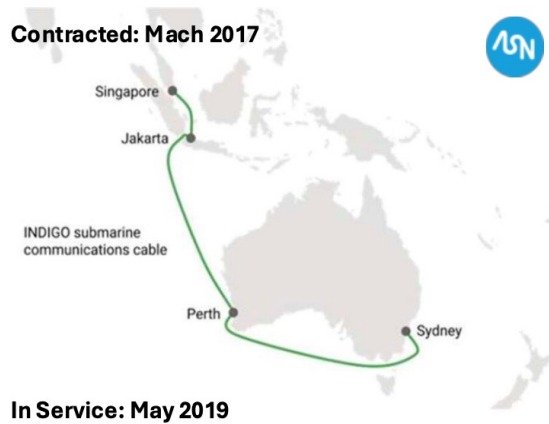
INDIGO West & Central

- INDIGO West
- Configuration: 2 Fibre Pairs
- Repeater Count: 56
- INDIGO Central
- Configuration: 2 Fibre Pairs
- Repeater Count: 55
- Each:
- Segment Length: ~ 4600 km
- Fibre type: Corning EX3000
- Day 1 FP Capacity: 18Tb/s
- Day 1 System Capacity: 36 Tb/s

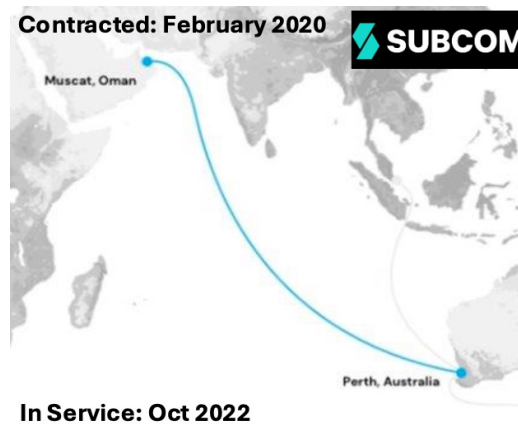
Oman Australia Cable (OAC)

- Configuration: 3 Fibre Pairs
- System Length: ~ 10,500 km
- Fibre type: OFS-Scuba-125
- Repeater Count: 111
- Day 1 System Capacity: 60 Tb/s

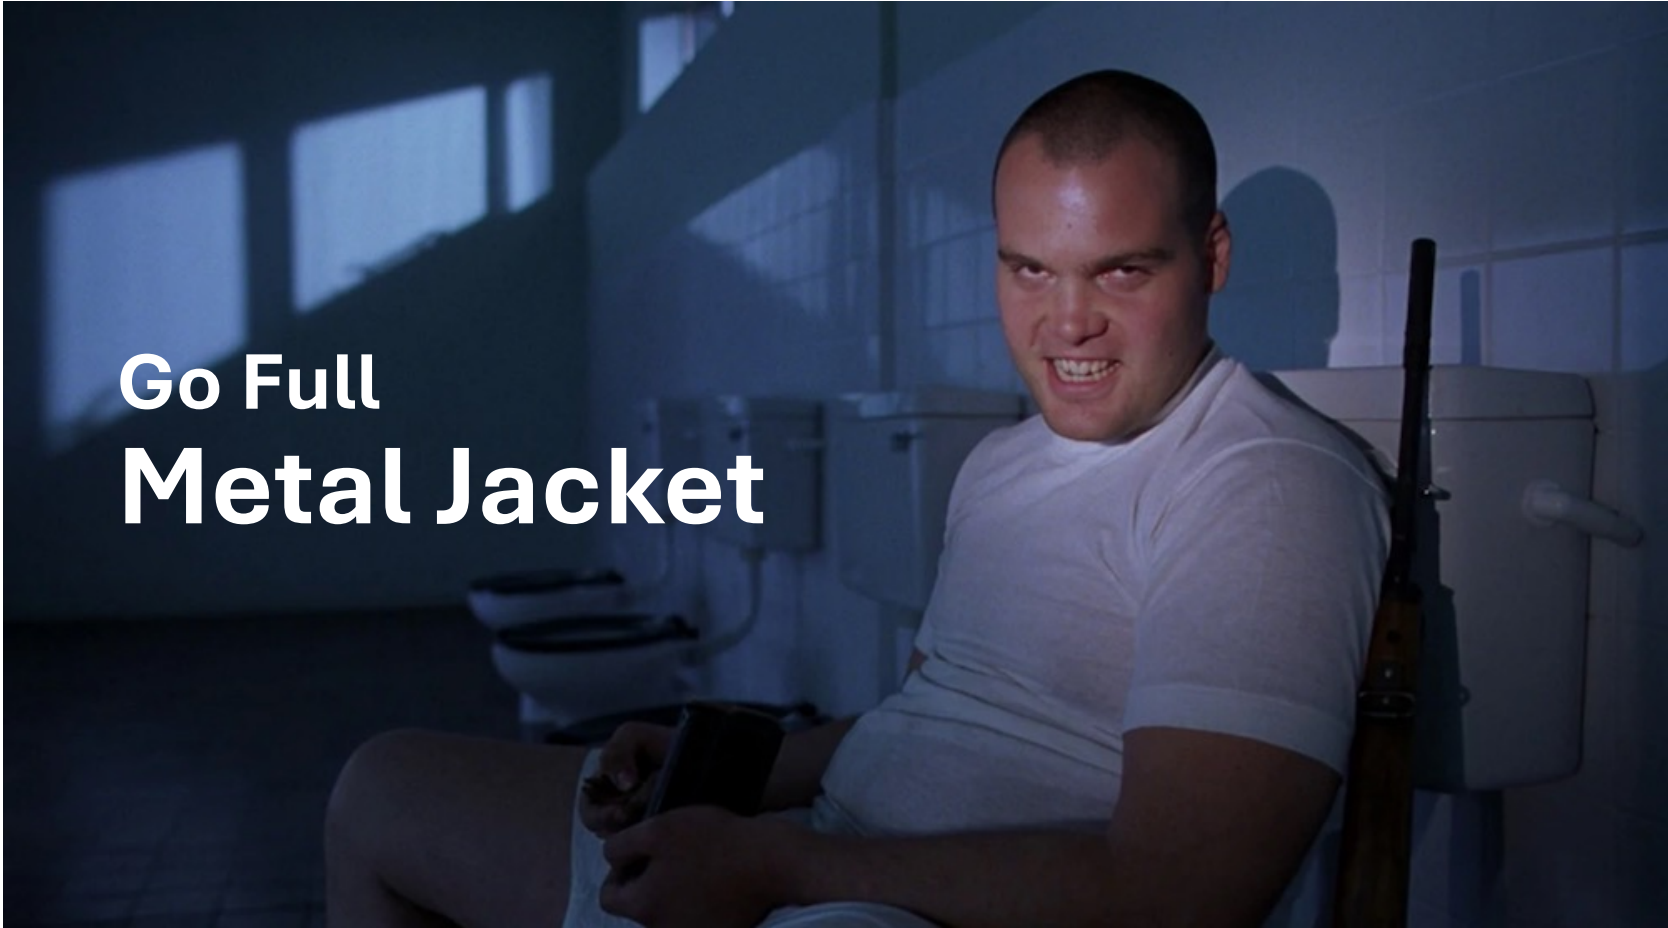
Go Full
Metal Jacket

Engineering Example – Full Metal Jacket

- Desktop survey and ocean survey had a design of approximately 60% of the overall system and 70% of trunk as light-weight (LW)
- Approximately 50% of LW was in the southern ocean which can be affected by high-seas during winter
- Cost to repair if there is a shunt fault AU\$2-3M
- Incremental cost to upgrade ~AU\$10M
- With correct installation likelihood of a shunt fault or break at depth is reduced to almost zero
- Increased reliability and security
- Represents a 2.5% increase in system investment

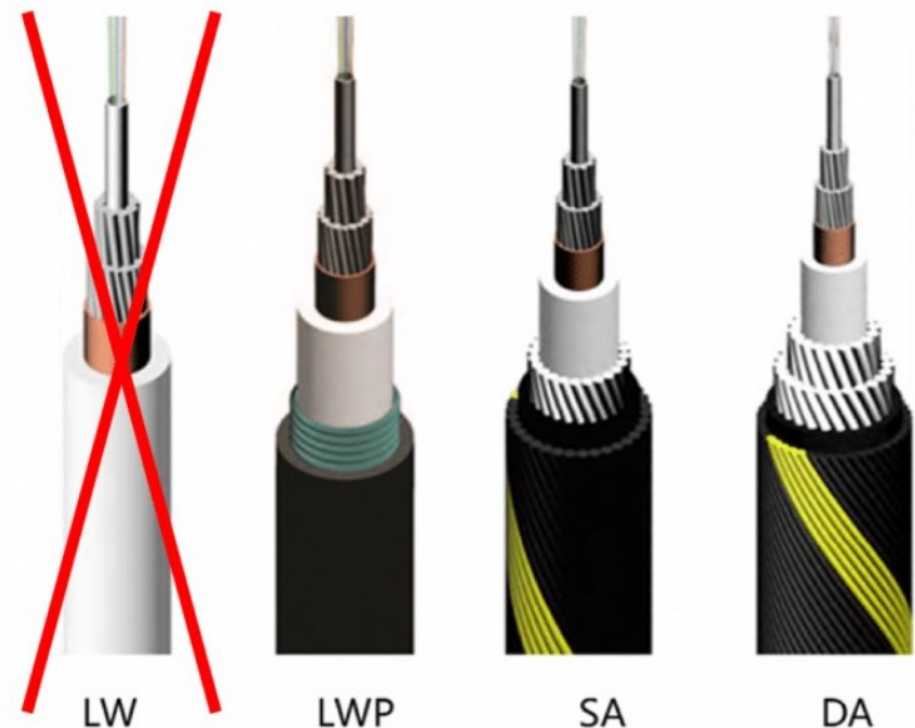
Engineering – Adelaide Branch

- ~330km branch of from BU in 3,000m water depth to West Beach Adelaide
- Majority of branch in shallow water less than 60m water depth
- 16FP switched branching unit capable of switching up to 8 pairs in:out of main trunk
- First long-haul fibre optic submarine cable to be installed into South Australia

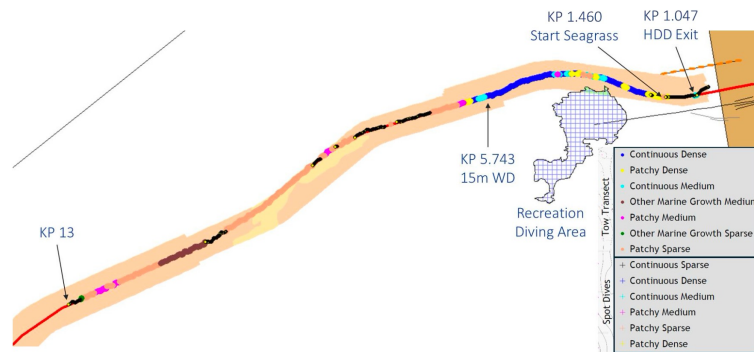
Articulated Pipe Proposal: SEG2.2

Adelaide Seagrass Section

1. Industrial practice to surface lay cable in seagrass area.
2. Solution: Surface lay + AP as additional protection.
3. Align with various United Nation effort to protect and conserve marine habitat. (<https://www.un.org/en/observances/seagrass-day>)

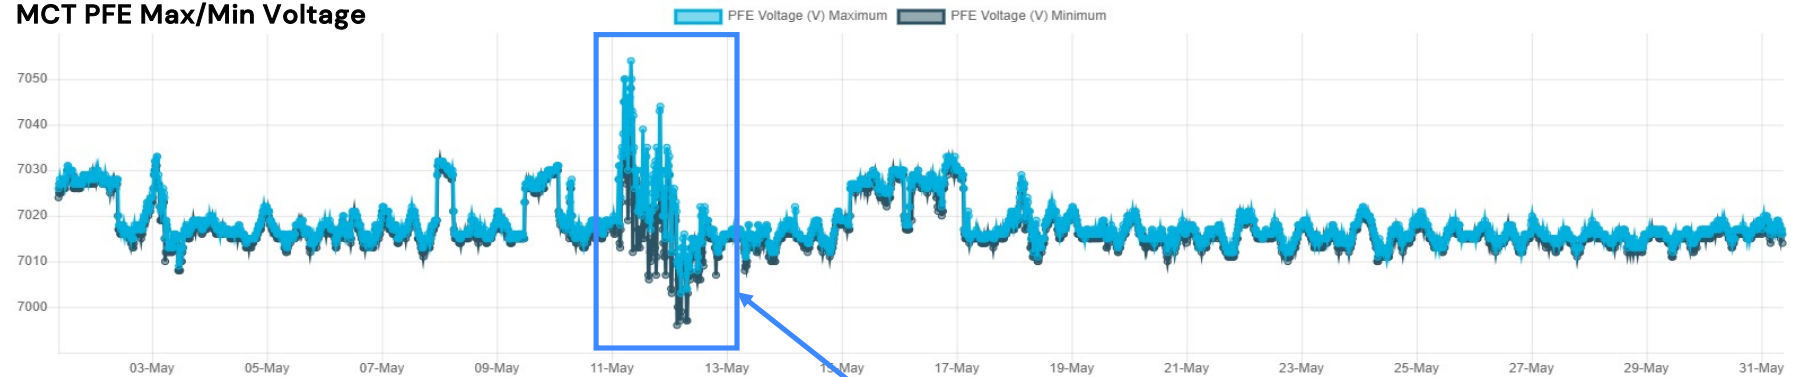
MCT PFE Max/Min Voltage

OAC Trunk PFE Voltages

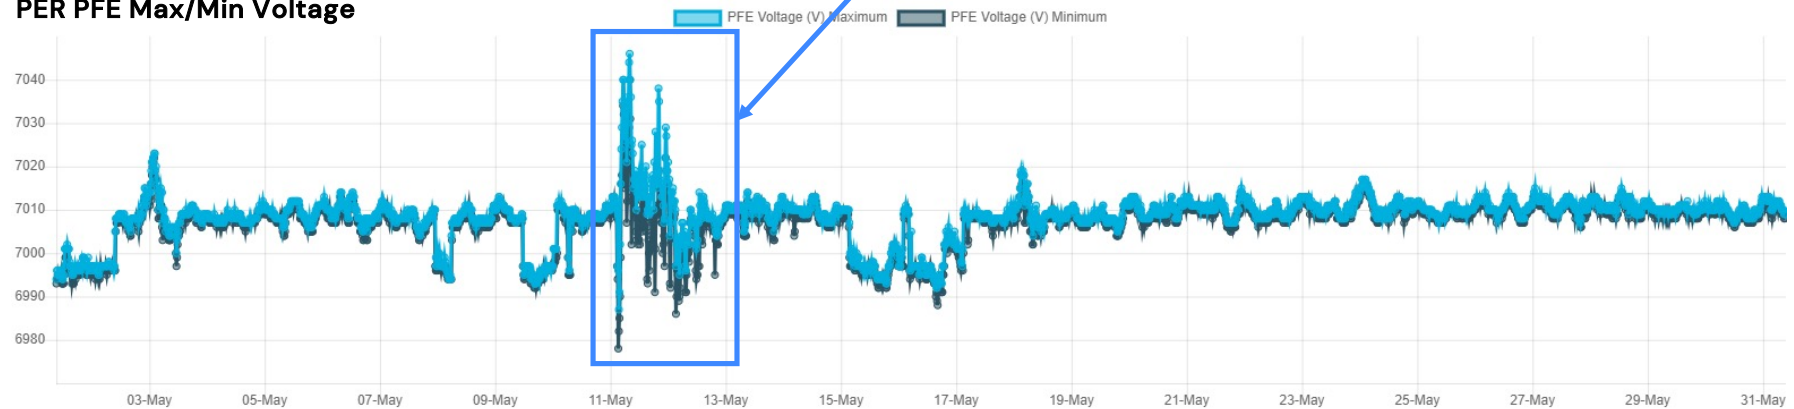
PER PFE Max/Min Voltage

Investigation Completed

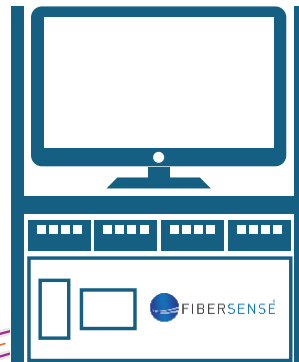
Interrogator Unit

Distributed Fiber Sensing (DFS): A box that converts existing optical fiber cables in Urban centres in to long continuous acoustic sensors

Optical pulses are sent down the fiber cable and the small reflections from the fiber are detected with a highly tuned receiver to pick up sounds around the cable

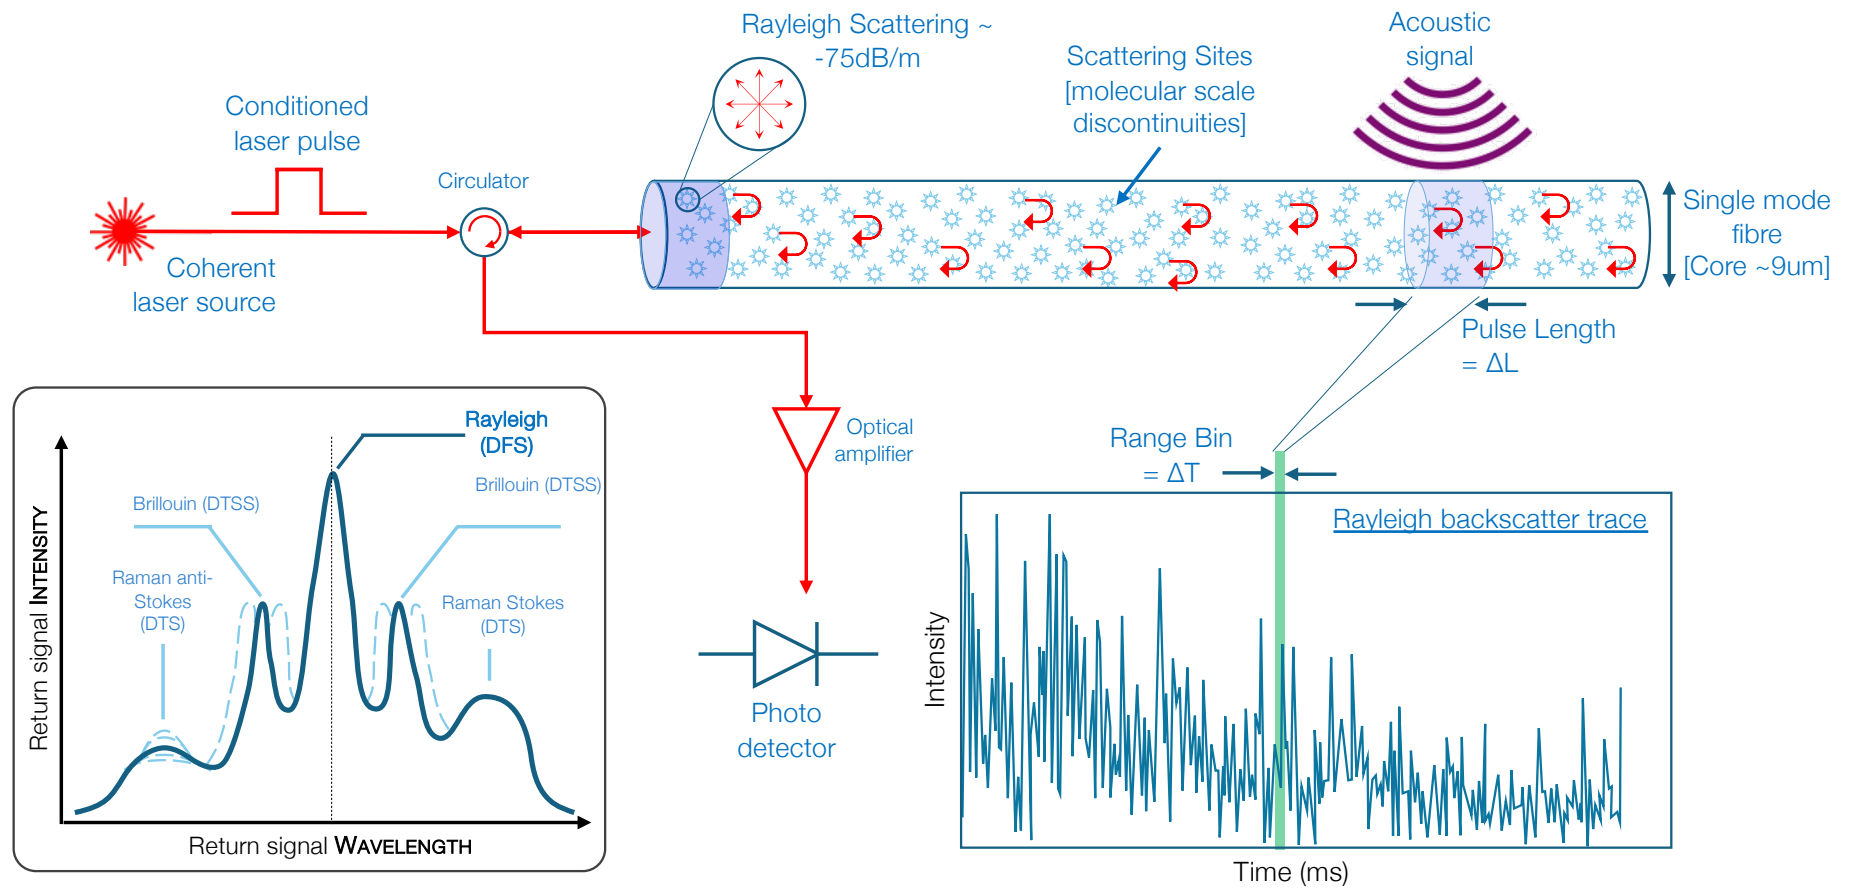
The Technology behind Fibersense

Proprietary ultra high performance implementation of Coherent Optical Time Domain Reflectometry (C-OTDR)

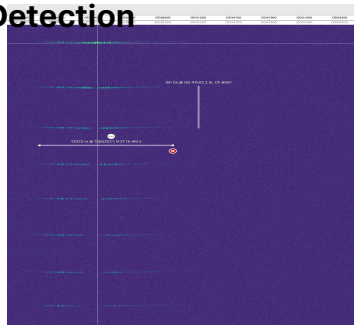
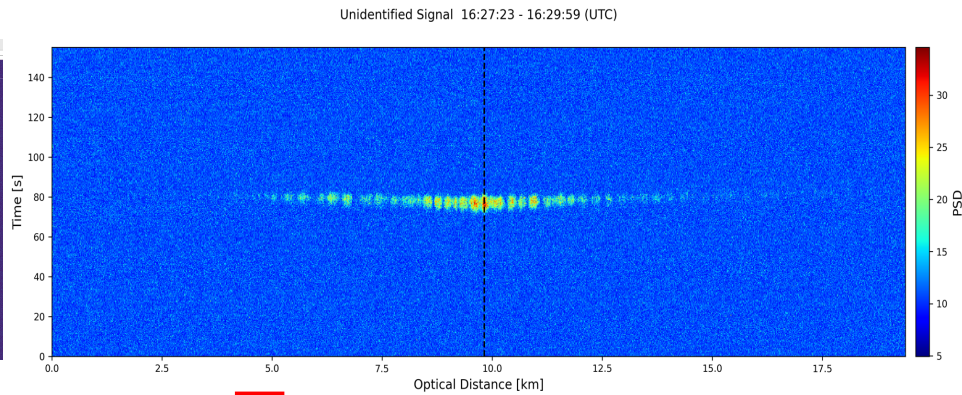
Marine Mammal Identification

5 whale identifications in Sep/Oct 2021

Narrowband Detection

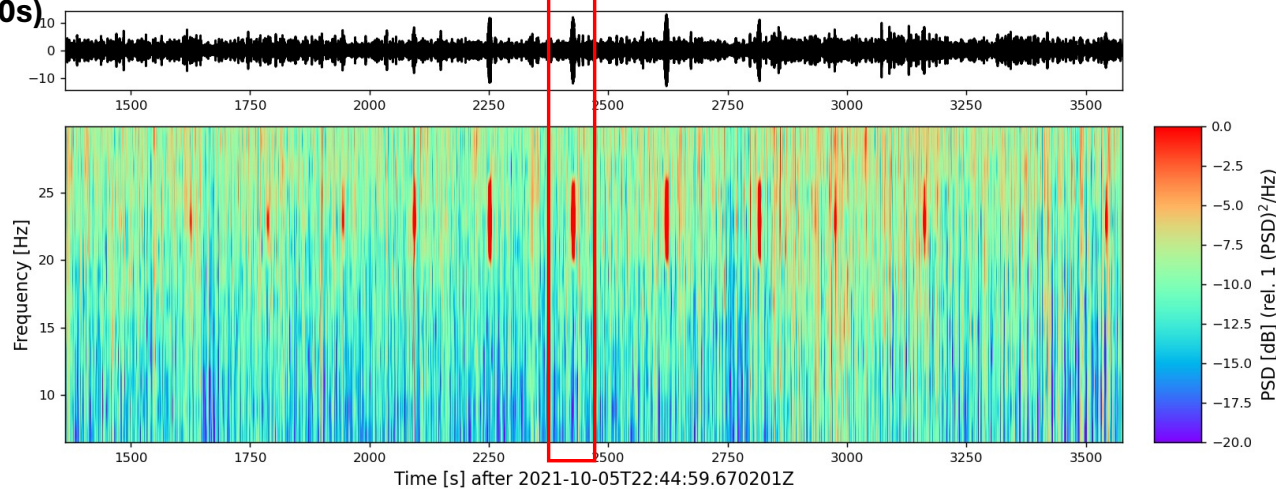
Repeating signal (every

Subco/Soda - AusNOG 2024 ~ 120s)

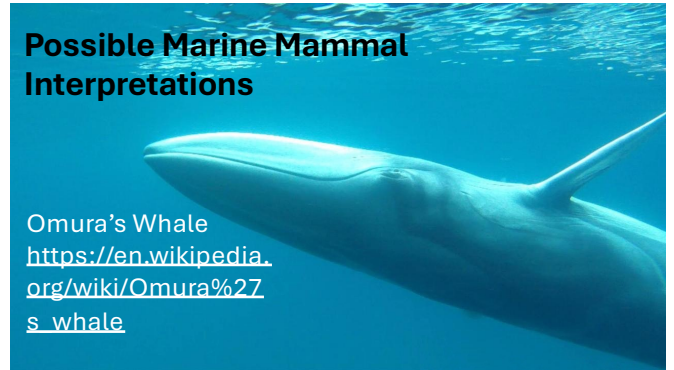
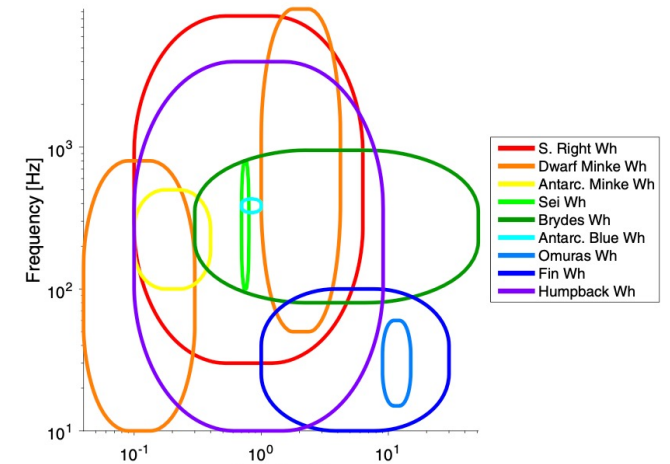
Possible Marine Mammal Interpretations

Omura's Whale
https://en.wikipedia.org/wiki/Omura%27s_whale

Pulse-like sounds by species from Erbe et al., 2017 Review of Marine Mammal Acoustics

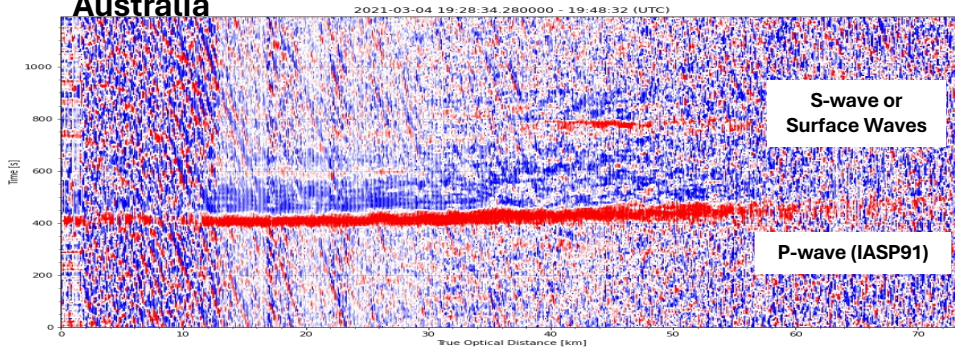
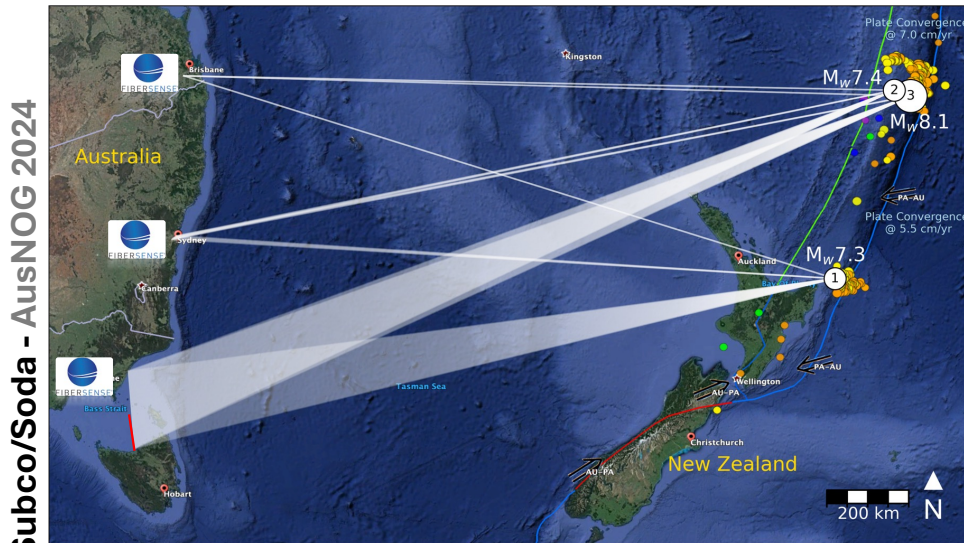
Tsunami Detection

Kermadec Arc Tsunami detection on Submarine Cable
M_w8.1 Mar-2021 Earthquake DAS Recording over Bass Strait, Australia

Megathrust earthquake north of New Zealand generated ~0.3 m of wave height in Bass Strait (3430km away) which is consistent with FS observations.

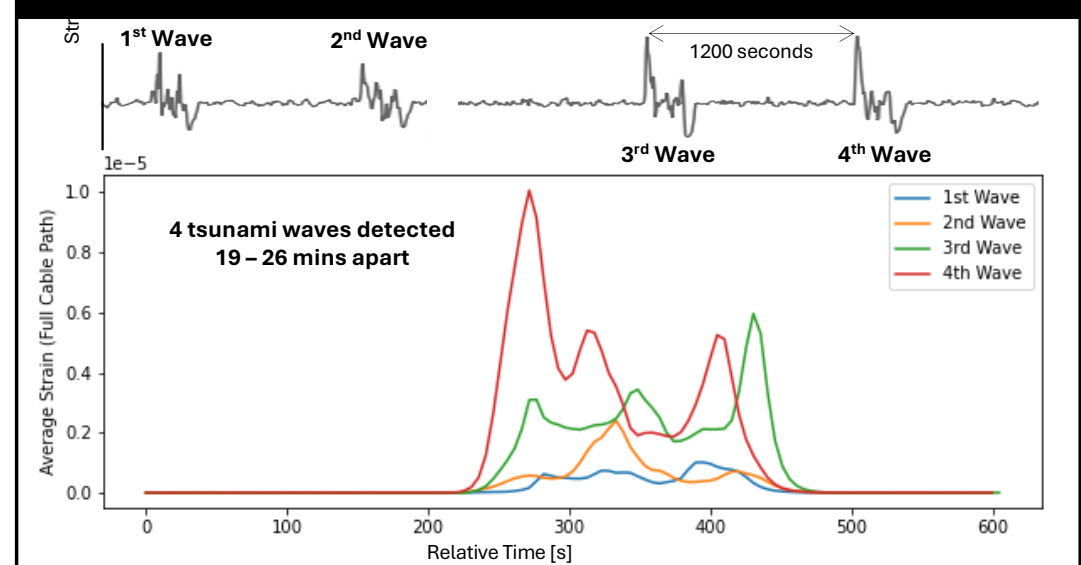
Tsunami Observations in Bass Strait 8.5 hrs after M_w8.1 Earthquake
