# Navigating the Upgrade Maze: A Tale of Modernising Router Software Versions

Jarryd Sullivan – National Engineering Manager

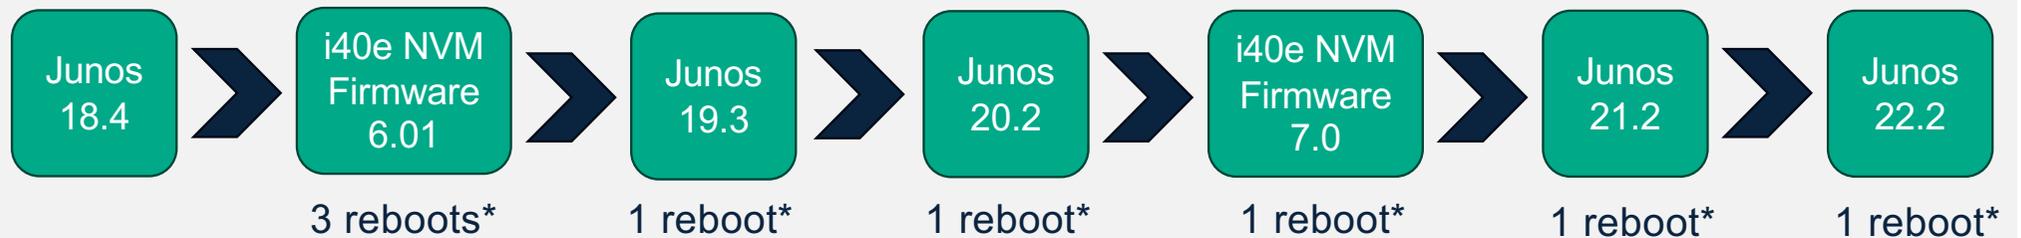
# Standard Upgrade Path

- Download next release, upgrade one RE at a time (noting dual RE systems are in use)
- Must adhere to rules of not skipping certain versions, resulting in a total of 6 upgrades being required
- Must complete at least 6 upgrades in a single maintenance window to avoid 4 known software bugs
- Two i40e NVM firmware upgrades required, with the upgrade to 6.01 requiring three reboots per RE. *Source - <https://lkhill.com/juniper-i40e-upgrade/> Special thanks to Lindsay Hill @ Valve (AS32590) for this wonderful blog on how to handle this process*
- Total of 14 reboots required to complete full upgrade cycle
- Total upgrade is approx. 16-18 hours in our lab testing (includes copying software to device)
- Won't fit in a 12am to 6am maintenance window (obviously)

\*For single RE system, double for dual REs
